Accessibility Audit

Date: March 2023

1.1 ACCESSIBILITY AUDIT

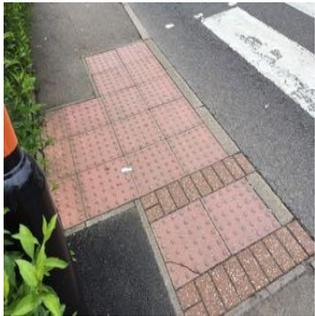
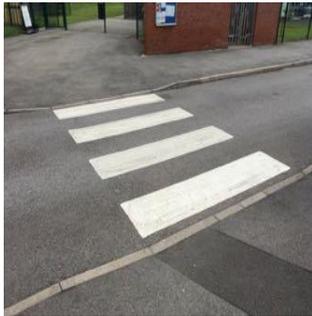
Question	Response	Details
<p>1.1 - Is the school within convenient walking distance of:</p> <ul style="list-style-type: none">- Public Highway and Pathways?- Public Transport e.g. Bus Stops?- Car parking?	C	<p>The school is close to public transport options and there is a car park available for school staff, visitors and children with specific medical needs (disabled spaces are available by the school entrance). There are no accessible car parks for parents. The school has two entrances which does help to disperse traffic however as result of the main drive being on a main road and the rear entrance leading to a housing estate, congestion can be an issue at drop-off and pick-up times. Parents wishing to use the car park need to obtain a pass from the school.</p>
<p>1.2 - Route free of kerbs? Do crossings on approach have tactile paving? If there are pedestrian crossings, do these have turn cones to aid people who are Deaf / Blind?</p>	C	<p>There is tactile paving provided to the crossing points on approach to the school to aid people with impaired vision.</p>

<p>1.3 - Wide enough? If a route or pathway is narrow, is there a suitable passing place for wheelchair users? Is plantation trimmed back and are low branches avoided?</p>	<p>No action</p>	<p>All of the routes are wide enough to accommodate wheelchair users. Regular ground maintenance ensures pathways are clear</p>
<p>1.4 - Surfaces even and slip resistant? Is paving flush with no cracks or gaps that could trap the wheels of a wheelchair?</p>	<p>No action</p>	<p>The approach to the entrances have surfaces which are even and slip resistant. The Site Supervisor does daily walks of the building and reports any concerns.</p>
<p>1.5 - Is the location of the school clearly identified from the street? Visual clues and sufficient landmarks to aid orientation?</p>	<p>C</p>	<p>There is a lack of on street signage on approach to the school. The school sign is set back from the road. There is a bush in front of the main sign which is maintained under the ground's maintenance. The school should ensure that this remains trimmed for access to the sign. There is no signage at the back of the school. ACTION: Look into additional signage and positioning to aid visibility</p>

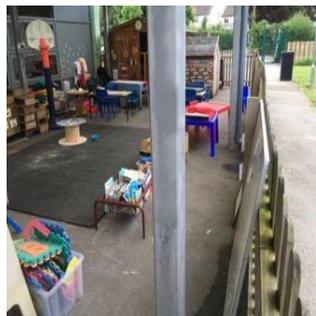
<p>1.6 - Free from hazardous building features such as outward-opening doors, windows or overhangs? Do columns or structural posts have markings at two heights?</p>	<p>B</p>	<p>The external columns within the reception class play area do not have markings provided at two heights, this could cause a potential collision hazard. ACTION: use tape to correct this issue</p>

Action	Priority	Cost	Comments
1.5 – Look into additional signage and positioning to aid visibility	C	M	Health and Safety Team with the Parish Council are looking at this
1.6 – Use tape to on structural posts to aid vision	B	M	
1.7 – Review seating on the playground	C	SC	
4.3 – Purchase a portable ramp for the Rainbow Room if the room becomes required for wheelchair access on a regular basis.	C	M	
4.7 – Add manifestations to the Rainbow Room doors	B	M	
5.6 – Add seat at a higher height in the main reception when purchasing new seating.	C	M	
5.7 – Update the trip/visitor checklist to include a question about accessibility	B	N	
5.8 – On the signing in form for visitors, add a statement which tells the visitor to let them know if they require support during a fire drill or any other support	B	N	
6.2 – Add a colour contrast to the Rainbow Room Step	B	N

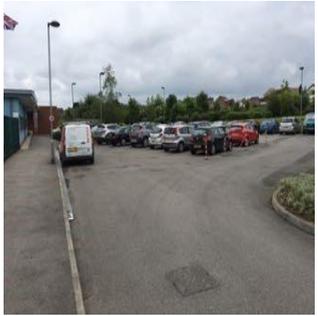
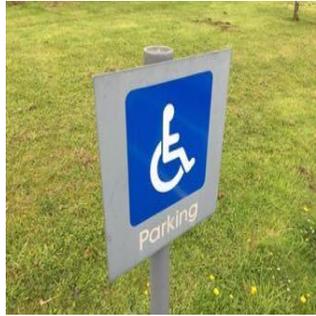
Checklist 2 - Car Parking		
Question	Response	Details
2.1 - Are accessible bays provided for badge holders?	No action	Accessible parking spaces are provided within the school car park.
2.2 - Accessible bays clearly sign-posted?	D	There is post -ounted signage provided to the front of the accessible parking spaces.

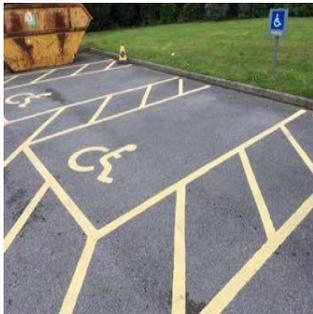
2.3 - Are bays marked out appropriately and easily identified?
Can car doors be fully opened to allow disabled drivers and passengers to transfer to a wheel chair parked alongside?

The accessible parking spaces are correctly marked out in accordance to BS8300. No issues to report.

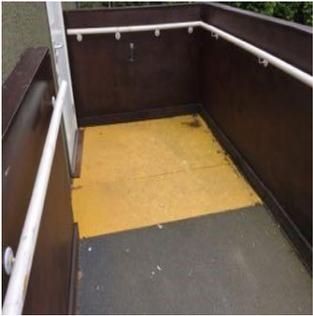
Checklist 3 - External Ramps		
Question	Response	Details
3.1 - Wide enough and suitably graded? Is there colour contrast to the surface of the ramp?	No action	The ramp up to the mobile has colour contrast to the surface to indicate the presence of a gradient. This will minimise a potential stumbling hazard. The outdoor classroom also has a ramp.

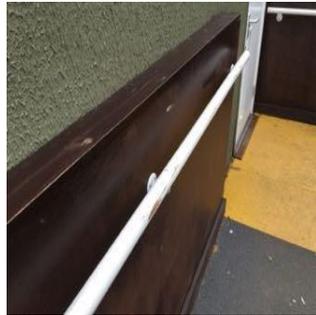
3.2 - Suitable handrails on each side?	No action	For the mobile, BS8300 compliant handrails are provided to both sides of the ramp. No issues to report. The outdoor classroom does not need a rail due to length and gradient of ramp.
----------------------------------------	-----------	----------------------------------------------------------------------------------------------------------------------------------------------------------------------------------------

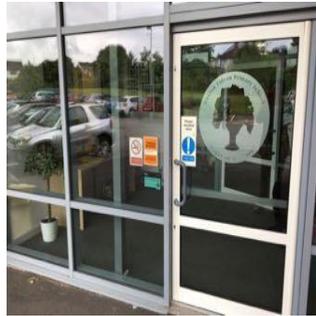
4.1 - Main school entrances easy to find? Is the entrance clearly distinguishable from facade?	No action	The main entrance is suitably colour contrasted against the surrounding facade to aid people with impaired vision.
------------------------------------------------------------------------------------------------	-----------	--------------------------------------------------------------------------------------------------------------------

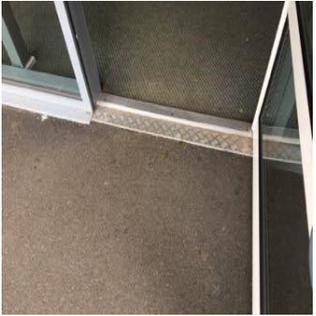
<p>4.2 - Door opening wide enough for all users? Enough space alongside leading edge for a wheel chair user to open the door while clear of the door swing?</p>	<p>No action</p>	<p>The main entrance has a width which provides sufficient clearance for wheelchair users. Press-button access for disabled users it located on the wall outside for entrance and in the reception lobby for exit.</p>
<p>4.3 - Level or flush threshold?</p>	<p>C</p>	<p>A level threshold is provided through the main entrance. The Rainbow Room has a step so requires a portable ramp.</p>

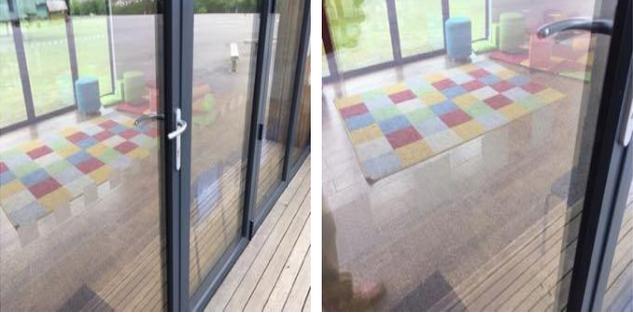
4.7 - Glazed entrance door: markings for safety and visibility? If manifestations are provided, are these suitably colour contrasted against their background?	B	Manifestations are provided at the main entrance. No issues to report. There are no manifestations on the entrance to the Rainbow Room.

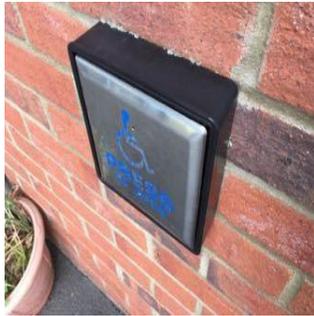
4.8 - Weather mat of firm texture and flush with floor?	No action	No issues to report.
4.9 - Are automatic doors provided? If so, do these remain open long enough for a slow-moving person to pass through? Are visual and tactile warnings provided? If automatic doors are operated via a push pad rather than a sensor, are these clearly seen on approach?	No action	<p>On the day of the survey, the timings of the automatic doors appeared to be sufficient to allow slow moving persons through without causing a potential collision hazard.</p> <p>The push pads are easy to see on approach.</p>

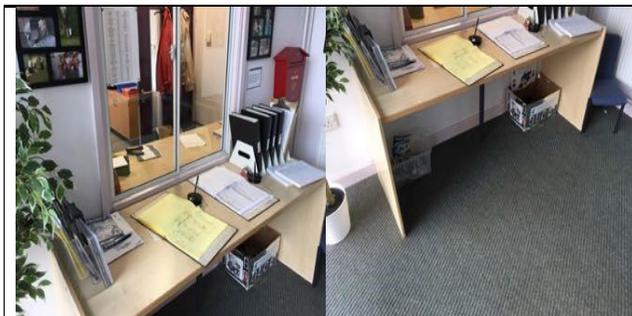
Question	Response	Details
5.1 - Clear view in from outside? Can receptionists see visitors and provide assistance if necessary?	No action	The main entrance is fully glazed which provides a clear view into the building and the front line staff are able to see if someone requires assistance.
5.2 - Transitional lighting? Is the entrance lobby and reception area well illuminated?	No action	The reception area is well lit and there is no glare that could cause potential difficulties for people who lip-read.
5.3 - Reception/desk/counter/ checkout suitable for approach and use from both sides by people either standing and seated?	No action	The reception is suitably designed to serve and be staffed by a wheelchair user. No issues to report.

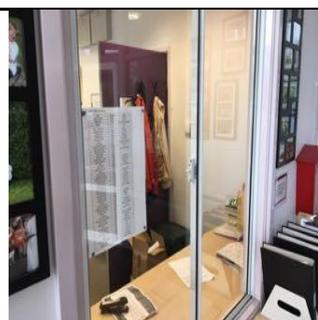
5.4 - If security permits the use of a glazed screen, is this nonreflective and free of glare which could hinder lip-readers?

The reception has a glazed screen which is reflective which is likely to cause potential difficulties for people who lip-read. Deemed reasonable to retain in the short term as the glass is typically pulled to one side when in use.

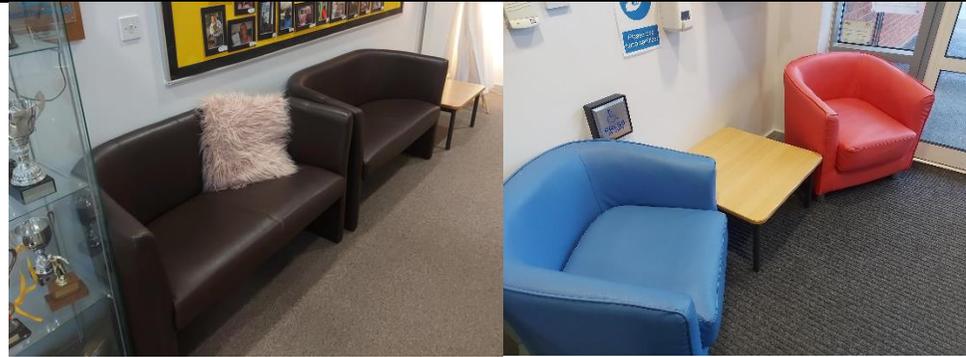
5.6 - Seating designed for ease of use? Is there a management procedure to ensure spaces are provided for wheelchair users?

The seats within the reception area do feature armrests to aid ambulant disabled persons. All chairs are all of low height.

ACTION: add one seat at a higher height

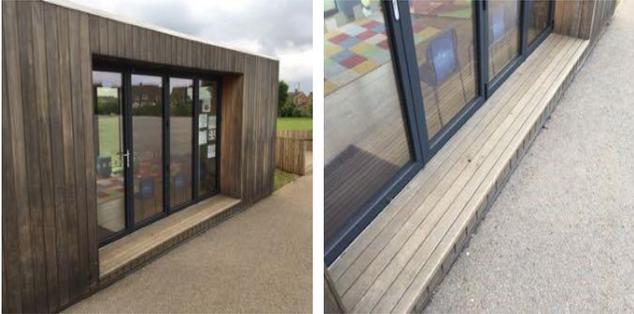
<p>6.1 - Corridor wide enough for a wheel chair user to manoeuvre and for other people to pass? Turning space for wheel chair users?</p>	<p>No action</p>	<p>Main corridors have widths which would easily accommodate wheelchair users. The building has been purposely designed with accessibility in mind. Staff are reminded to keep corridors clear. Health and Safety Ambassadors do regular checks to ensure routes are accessible.</p>
<p>6.2 - Are all key facilities within the school accessible for all users? Where there are facilities not available are there alternative means of access procedures in place?</p>	<p>B</p>	<p>There is no step free access available into the external Rainbow Room denying access for wheelchair users. Note, there is no colour contrast provided to the edge of the step.</p>

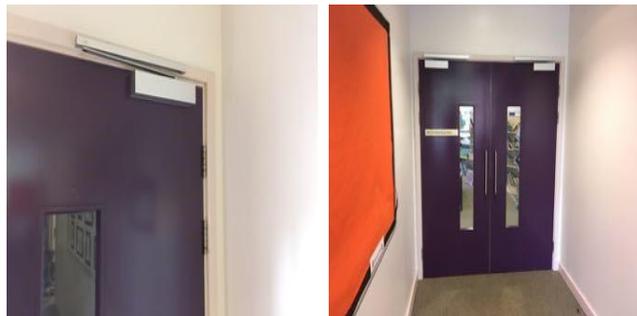
Question	Response	Details
7.1 - Distinguishable from surroundings?	No action	The doors are suitably colour contrasted against their surroundings. The use of purple seen against white walls provides excellent colour contrast.

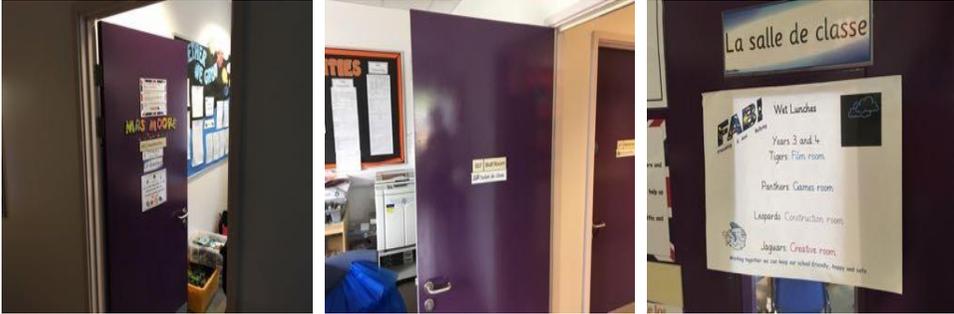
<p>7.2 - Can people each side of the door, either standing or seated, see each other and be seen? Are vision panels kept clear of temporary notices? (for an example classroom entrances)</p>	<p>C</p>	<p>Key doors throughout have the appropriate vision panels however there are a select number that do not such as the entrance for the staff room or for the Headteacher's office. This could cause a potential collision hazard.</p> <p>On the day of the survey, some vision panels had notices on them causing a potential collision hazard. ACTION: vision panels should not be covered unless it is a lockdown situation.</p>

7.2 – Ensure that vision panels on classroom doors are not covered unless it is a lockdown	C		
8.6 – When the foundation stage toilets are decorated, look at adding a grip rail in the widest toilet in Foundation Stage	C	M	
10.1 – When new furniture is required for the main reception and staffroom, purchase chairs with armrests	C	M

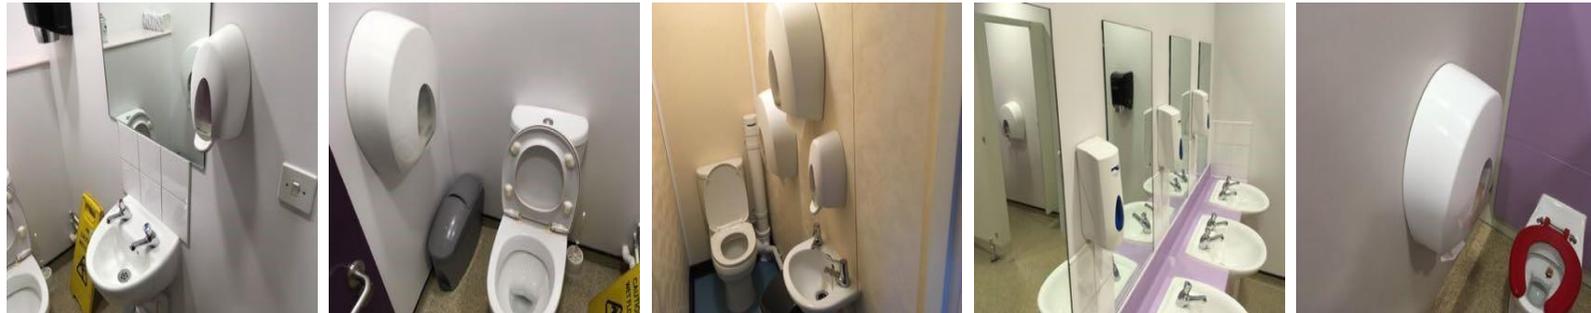
Question	Response	Details
8.1 - Lobby door light enough to open easily? Lobby of sufficient size for easy access?	No action	No issues to report.
8.2 - Slip-resistant floors throughout?	No action	Slip resistant flooring is provided within each of the WCs.
8.3 - Fittings all easily distinguishable from background? Are hand dryers and sanitary ware easily seen against their surroundings?	C	Throughout all of the WCs the colour contrast is poor. The fittings and fixtures are not easily seen against their backgrounds. Items are generally white seen against a similar coloured wall.

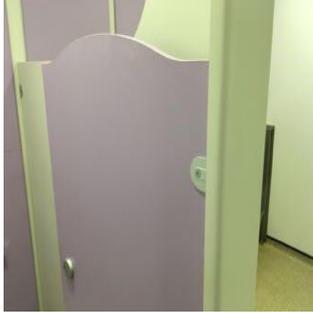
8.4 - Compartment door controls all easily gripped and operated? Are cubicle doors suitably colour contrasted against the panels?	No action	Cubicle doors throughout are appropriately colour contrasted to aid people with impaired vision. Controls were also identified as being easy to use.
-----------------------------------------------------------------------------------------------------------------------------------	-----------	------------------------------------------------------------------------------------------------------------------------------------------------------

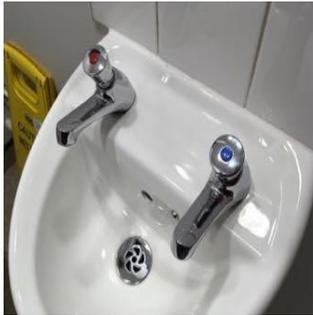
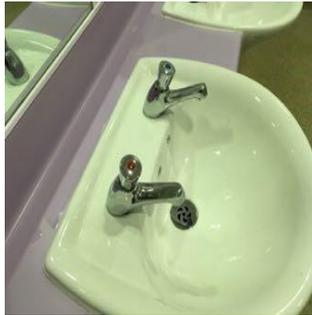
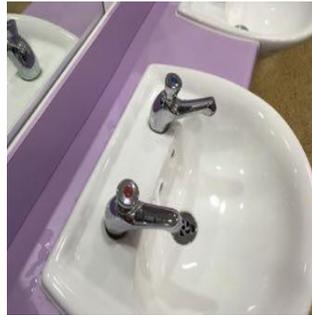
8.5- Are lever style taps provided within the WCs to aid people with dexterity impairments?

WCs do not have lever style or sensor operated taps to aid people with dexterity impairments, taps are generally of the push type. Lever style taps are available in the disabled toilets and can be accessed by children who require this system.

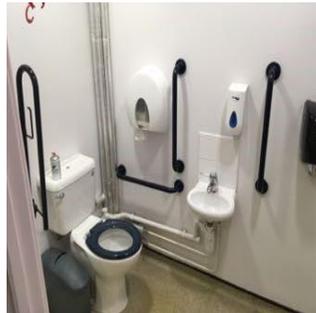
<p>9.1 - Compartment large enough to allow manoeuvring into position for frontal, lateral, angled and backward transfer unassisted and with assistance?</p>	<p>No action</p>	<p>The school is extremely well equipped with toilet facilities for disabled people. There are four accessible WCs available, one is a medical room which also has a level access shower. All facilities have the appropriate dimensions in accordance to BS8300. There is also an ambulant cubicle within the reception classroom.</p>
-------------------------------------------------------------------------------------------------------------------------------------------------------------	------------------	-----------------------------------------------------------------------------------------------------------------------------------------------------------------------------------------------------------------------------------------------------------------------------------------------------------------------------------------

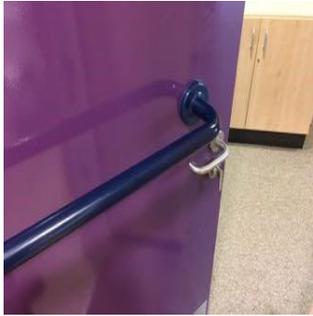
<p>9.2 - Travel distance to a suitable WC no greater than that for able-bodied people?</p>	<p>No action</p>	<p>The accessible WCs are sporadically and well positioned throughout the school. No issues to report.</p>
<p>9.3 - Sufficient space available outside toilet compartment for manoeuvre? Is the entrance wide enough and does it open outwards?</p>	<p>No action</p>	<p>The accessible WCs have outward opening doors which will make it easy to assist someone within the WC should they stumble and rest against the entrances.</p>
<p>9.4 - Door controls, lock and light switch easily reached and operated? Is there a grab rail to the inner face of the entrance?</p>	<p>No action</p>	<p>The accessible WCs have a grab rail provided to the inner face of the entrances and the locks are deemed easy to use. No issues to report.</p>

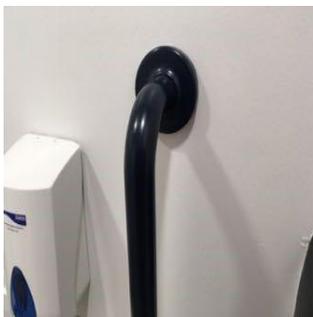
9.6 - Suitably designed grab rails fitted in all positions necessary to assist manoeuvring? Are grab rails suitably colour contrasted to aid people with impaired vision?

BS8300 compliant grab rails are provided throughout the accessible WCs and they are well contrasted against their surround to aid people with impaired vision. The use of blue grab rails seen against white walls provides sufficient colour contrast.

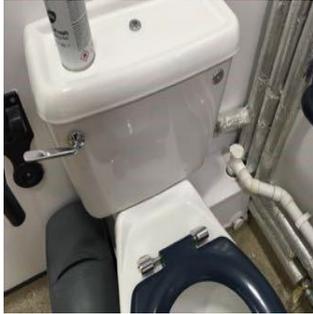
9.7 - Is there a back rest provided to the toilet pan?

There is no backrest provided to the rear of the accessible WC toilet pans. However, the Hygiene Room has a special seat which does have a back rest

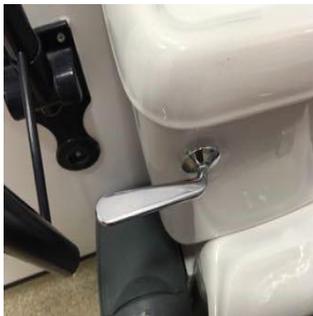
9.8- Is the flush of a suitable spatula type and is it appropriately located on the transfer side of the toilet pan?

The flush within the accessible WC near the staff room is not of spatula style however it is located on the correct side of the toilet pan.

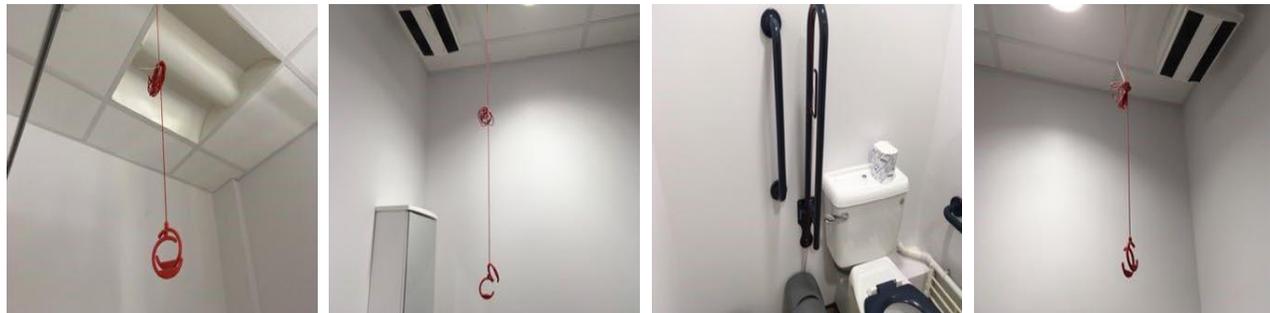
<p>9.10 - Is there a cord alarm? Is this coloured red with two triangular bangles and easy to reach from floor level?</p>	<p>No action</p>	<p>There is a red cord alarm in all disabled toilets which is easy to reach.</p>
---------------------------------------------------------------------------------------------------------------------------	------------------	----------------------------------------------------------------------------------

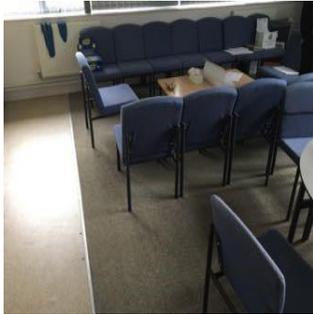
10.1 - Are seats provided at intervals along long internal routes or where waiting likely? Seats stable, with armrests and provided in a range of heights? Space for wheelchair user to pull up alongside a seated companion?

There are no chairs with armrests provided within the staff room to aid ambulant disabled persons.

There should be a chair with armrests provided within the lobby waiting area. **ACTION – purchase armrest chairs**

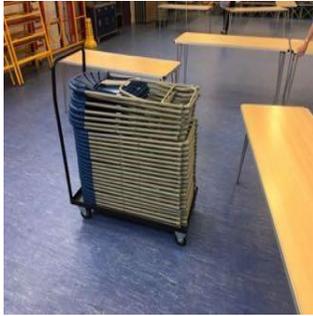
10.3 - Do the dining / cafe areas have appropriate seating rather than fixed seating which can be inaccessible for a range of users?

Non fixed seating is provided for dining times which is easily movable and adjustable.

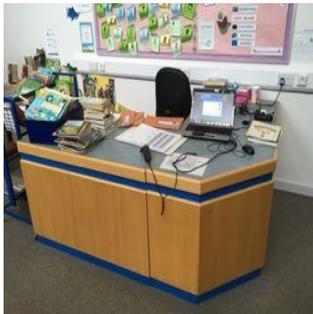
10. - Is there a dropped counter and an induction loop available for the Library counter?

Deemed reasonable to retain.

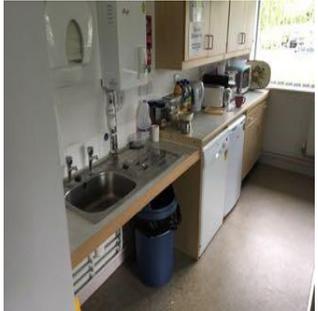
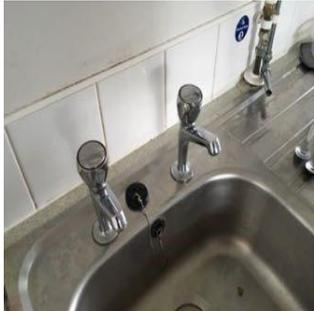
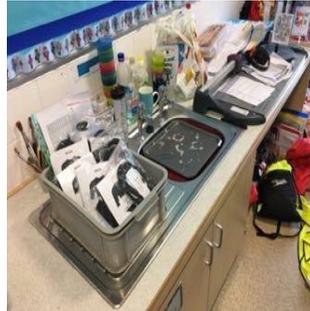
10.6 - Do staff and general kitchenette areas have a lever tap to accommodate people with dexterity impairments? Are there split height work surfaces available? Are there lever taps within the classrooms?

The kitchenette within the staff room does not feature lever taps to aid people with dexterity impairments. Wheelchair users would find the sink easy to use as there is suitable knee recess available.

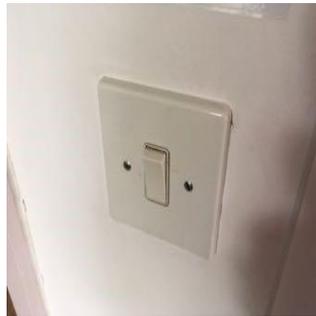
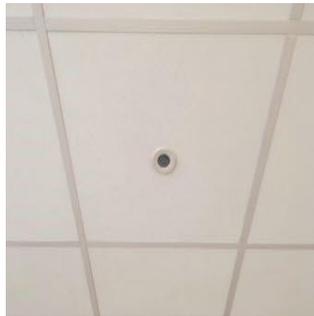
Question	Response	Details
12.1 - Lighting designed to meet a wide range of users needs? Level of lighting sufficient for intended use? Lights positioned where they do not cause glare, reflection, confusing shadows or pools of light and dark?	No action	No issues to report. Lighting was deemed to be excellent throughout the school.
12.2 - Can occupiers control lighting? Are light switch plates suitably colour contrasted and appropriately positioned for a wheelchair user?	D	Sensor lighting is provided throughout the school which is not only energy efficient but also far more accessible than light switches that may not colour contrast against the walls or be positioned at awkward heights for wheelchair users.

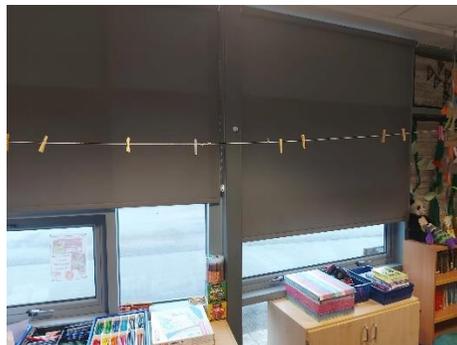
12.3 - Are learning spaces appropriately illuminated and are blinds available to control the natural day lighting? Is glare avoided which can hinder attempts by people with hearing impairments to lip-read?	No action	Roller blinds are provided within the classrooms which helps to control the glare that could hinder people trying to lip-read.
---------------------------------------------------------------------------------------------------------------------------------------------------------------------------------------------------------------	-----------	--------------------------------------------------------------------------------------------------------------------------------

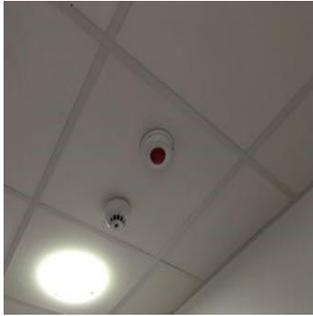
13.1 - Audible alarm system supplemented by visual system?	No action	There are visual strobe alarms to inform people with hearing impairments in the event of the fire alarm being activated.
------------------------------------------------------------	-----------	--------------------------------------------------------------------------------------------------------------------------

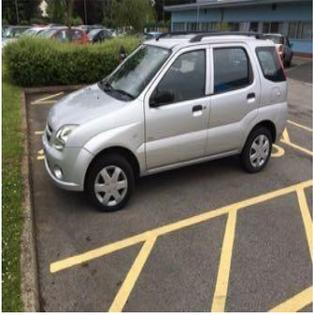
<p>14.2 - Accessible parking; Designated spaces not used by non-disabled drivers and kept free from obstructions?</p>	<p>C</p>	<p>Due to limitations on parking, disabled bays are used to ensure access of the site. Priority is always given to blue-badge holders.</p>
